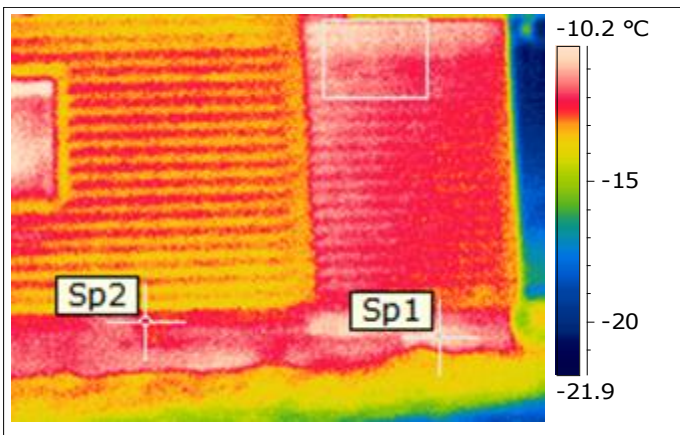
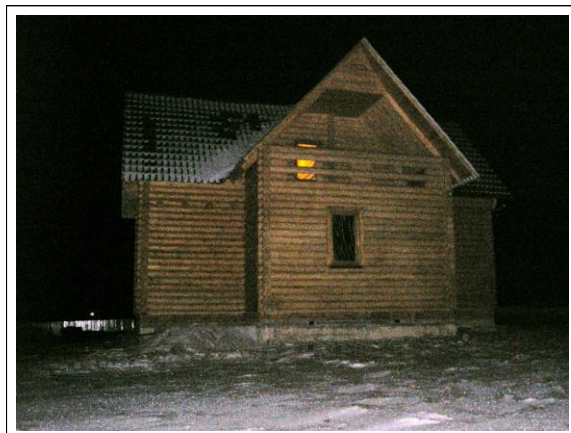
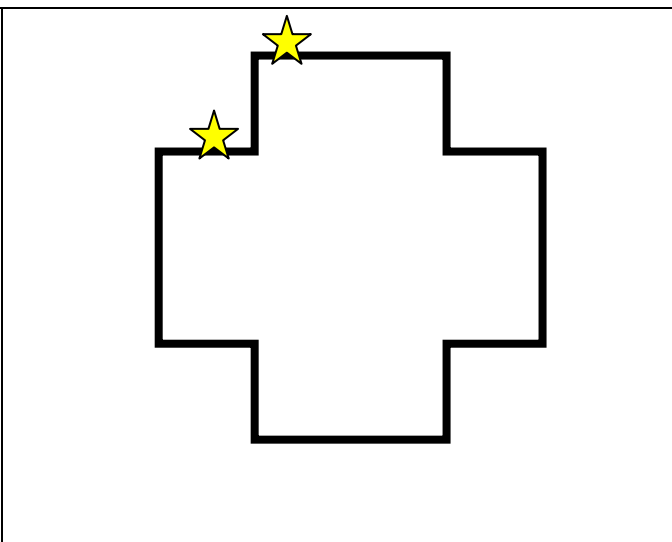
Date	14.12.2009
Image Time	18:00:33
Image Camera Type	ThermaCAM E300
Emissivity	0.95
Object Distance	7.0 m
Reflected Apparent Temperature	-13.0 °C
Atmospheric Temperature	-20.0 °C
Ar1 Максимальная температура	-10.2 °C
Sp1 Температура	-10.8 °C
Sp2 Температура	-12.3 °C

Comment: тепловые потери через неутепленный цоколь. Неравномерная температура по цоколю точки замера Sp1 и Sp2. Градиент температур достигает 3 C. Зона повышенных теплотерь стены здания область Ar1. Максимальная температура на поверхности -10,2C

Recommendation: провести утепление цоколя.

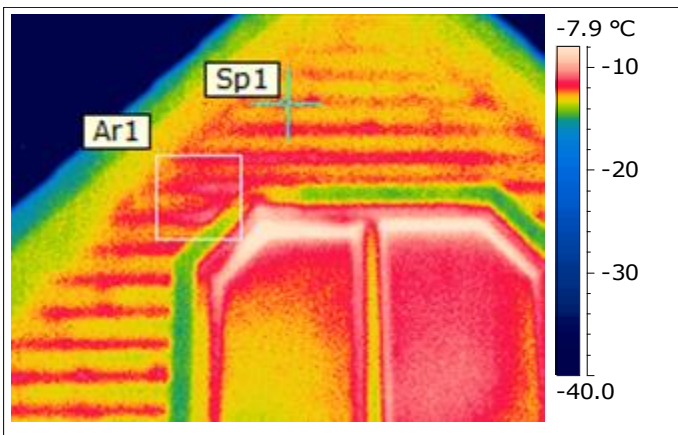
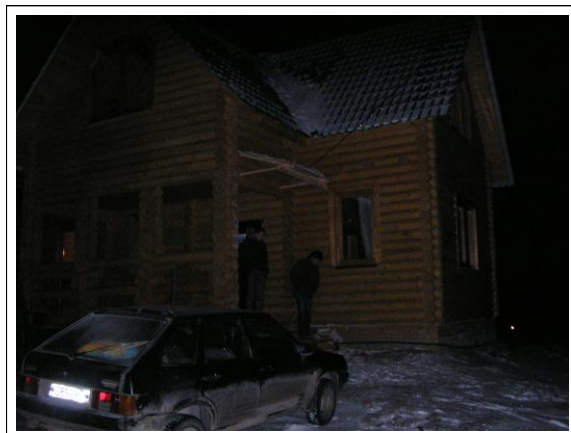
Comment: тепловой дефект в зоне примыкания окна .

Recommendation: Провести заделку и устранение

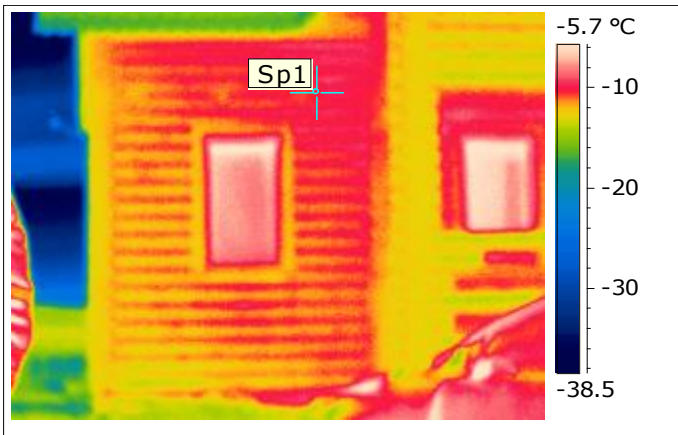
Date	14.12.2009	Зона повышенных теплопотерь на 2 этаже спальни. Дефект связан с некачественной заделкой стыков бревен.
Image Time	18:09:02	
Image Camera Type	ThermaCAM E300	
Emissivity	0.95	
Object Distance	6.0 m	
Reflected Apparent Temperature	-13.0 °C	
Atmospheric Temperature	-20.0 °C	
Sp1 Температура	-10.3 °C

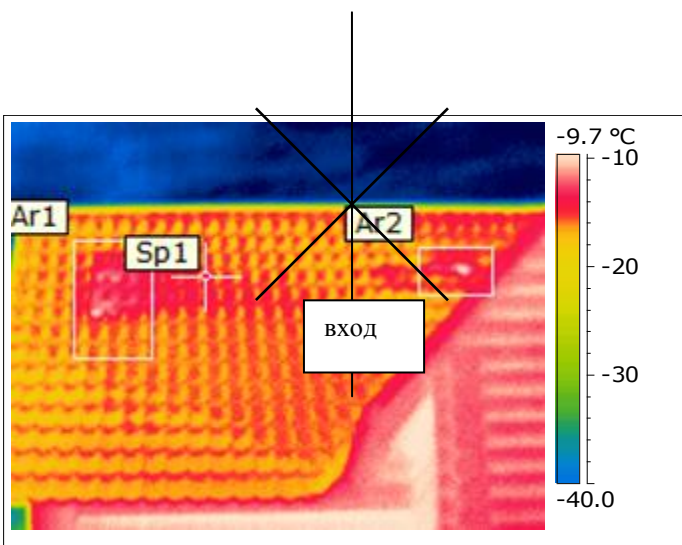
Comment: Дефекты утепления кровли

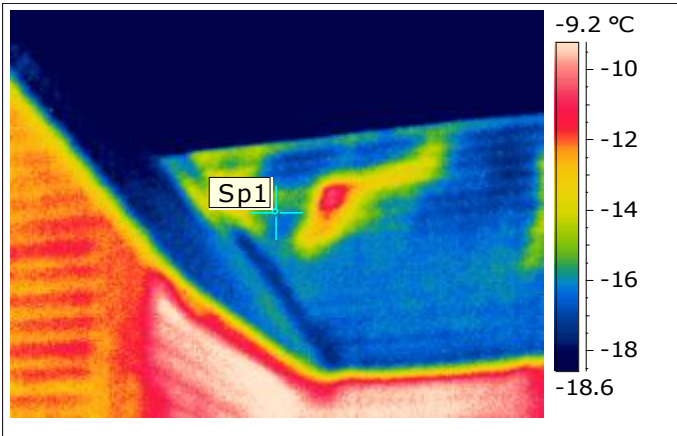
Date	14.12.2009
Image Time	18:11:44
Image Camera Type	ThermaCAM E300
Emissivity	0.95
Object Distance	7.0 m
Reflected Apparent Temperature	-13.0 °C
Atmospheric Temperature	-20.0 °C
Sp1 Температура	-16.2 °C

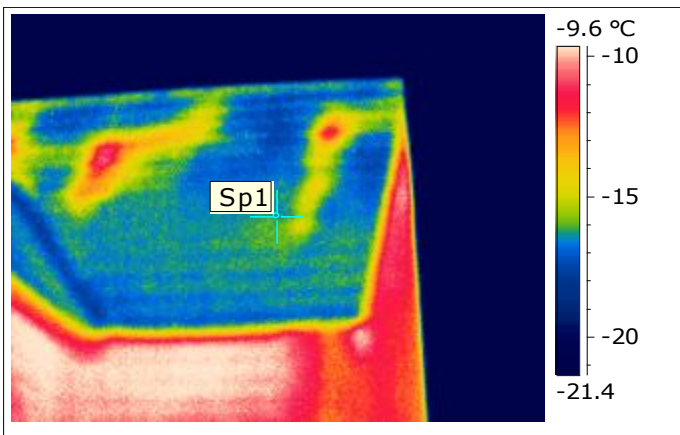
Date	14.12.2009
Image Time	18:11:56
Image Camera Type	ThermaCAM E300
Emissivity	0.95
Object Distance	8.0 m
Reflected Apparent Temperature	-13.0 °C
Atmospheric Temperature	-20.0 °C
Sp1 Температура	-16.5 °C

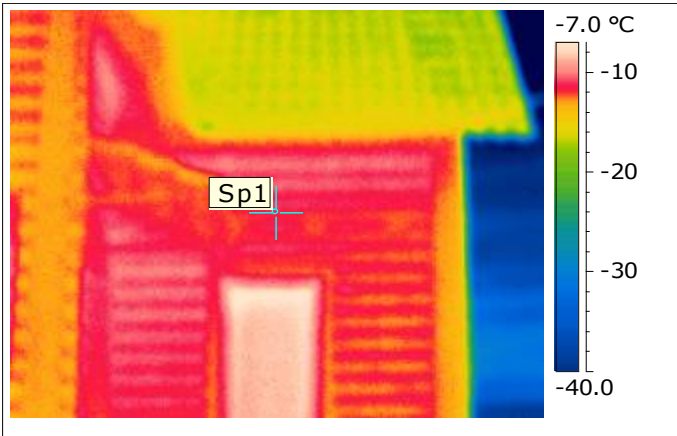
Date	14.12.2009	Location:	(Where)
Image Time	18:14:56	Other remarks:	
Image Camera Type	ThermaCAM E300		
Emissivity	0.95		
Object Distance	2.0 m		
Reflected Apparent Temperature	-13.0 °C		
Atmospheric Temperature	20.0 °C		
Sp1 Температура	-11.8 °C

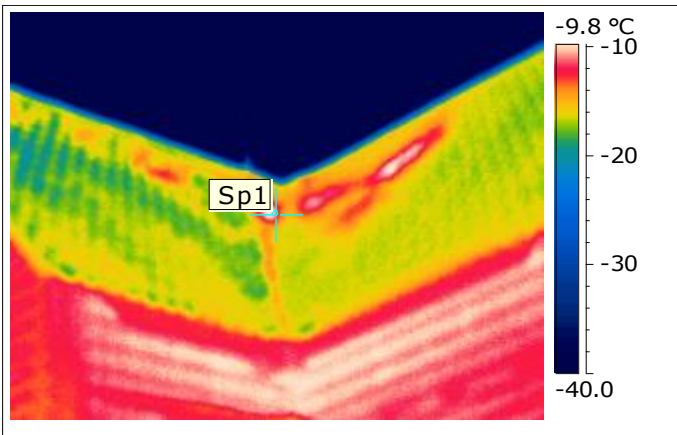
Date	14.12.2009	Location:	(Where)
Image Time	18:16:39	Other remarks:	
Image Camera Type	ThermaCAM E300		
Emissivity	0.95		
Object Distance	6.0 m		
Reflected Apparent Temperature	-13.0 °C		
Atmospheric Temperature	-20.0 °C		
Sp1 Температура	-11.9 °C

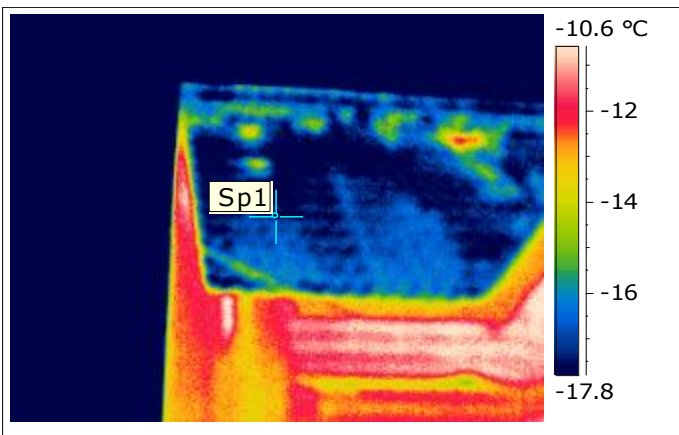
Date	14.12.2009	Location: (Where)
Image Time	18:17:29	Other remarks:
Image Camera Type	ThermaCAM E300	
Emissivity	0.95	
Object Distance	2.0 m	
Reflected Apparent Temperature	-13.0 °C	
Atmospheric Temperature	20.0 °C	
Sp1 Температура	-17.3 °C

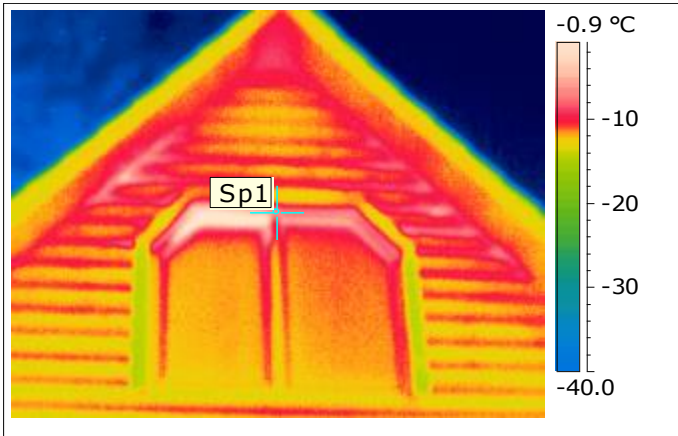
Date	14.12.2009	Location:	(Where)
Image Time	18:18:16	Other remarks:	
Image Camera Type	ThermaCAM E300		
Emissivity	0.95		
Object Distance	2.0 m		
Reflected Apparent Temperature	-13.0 °C		
Atmospheric Temperature	20.0 °C		
Sp1 Температура	-7.1 °C

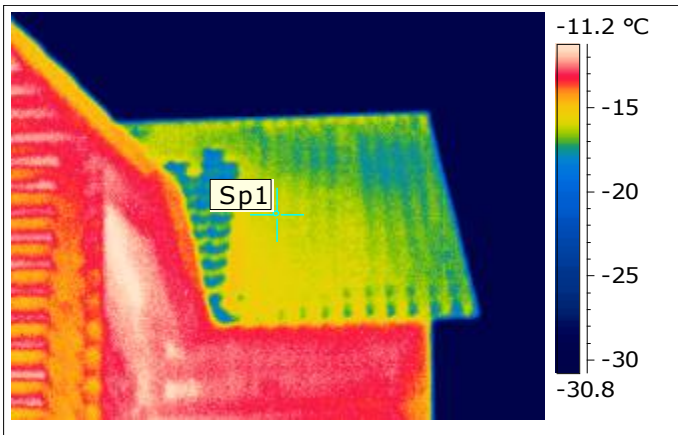
Date	14.12.2009	Location:	(Where)
Image Time	18:19:05	Other remarks:	
Image Camera Type	ThermaCAM E300		
Emissivity	0.95		
Object Distance	2.0 m		
Reflected Apparent Temperature	-13.0 °C		
Atmospheric Temperature	20.0 °C		
Sp1 Температура	-16.1 °C

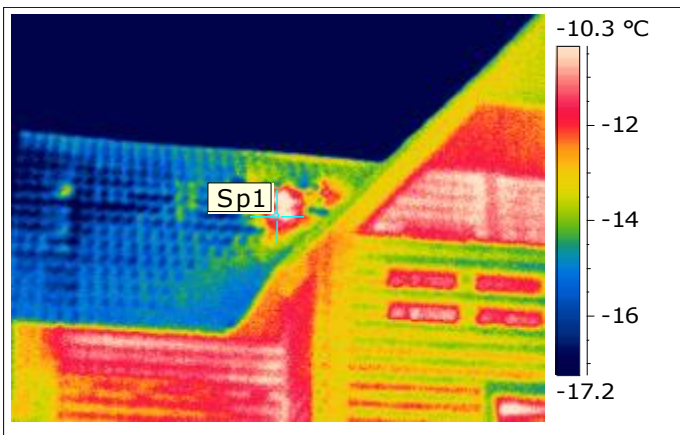
Date	14.12.2009	Location:	(Where)
Image Time	18:19:53	Other remarks:	
Image Camera Type	ThermaCAM E300		
Emissivity	0.95		
Object Distance	2.0 m		
Reflected Apparent Temperature	-13.0 °C		
Atmospheric Temperature	20.0 °C		
Sp1 Температура	-11.1 °C

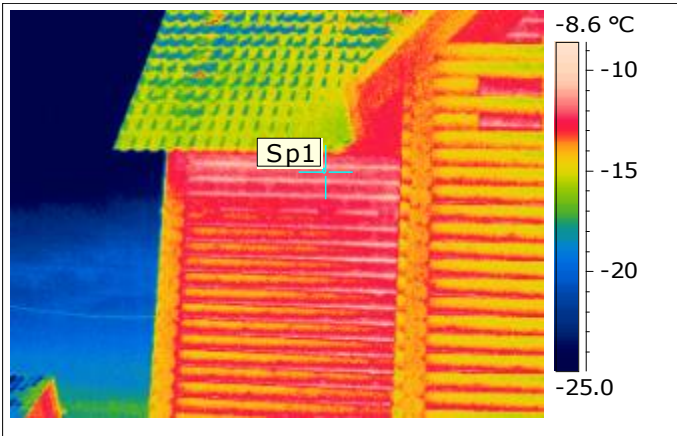
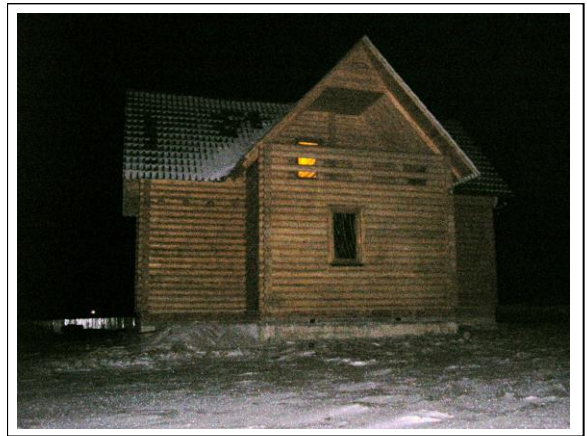
Date	14.12.2009	Location: (Where) Other remarks: некачественная заделка стыков на 2 этаже
Image Time	18:21:39	
Image Camera Type	ThermaCAM E300	
Emissivity	0.95	
Object Distance	2.0 m	
Reflected Apparent Temperature	-13.0 °C	
Atmospheric Temperature	20.0 °C	
Sp1 Температура	-11.9 °C

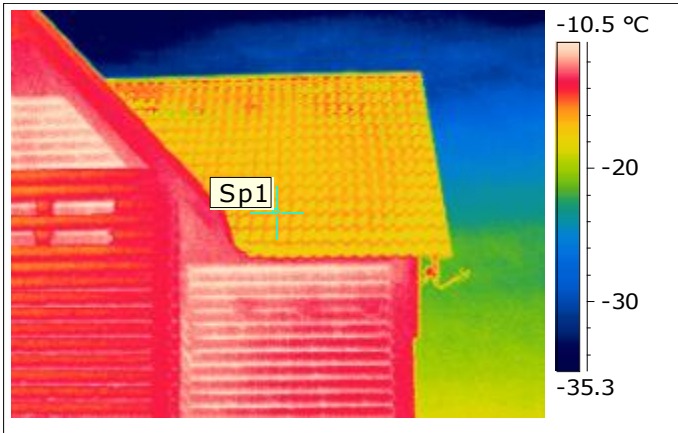
Date	14.12.2009	Location: (Where)
Image Time	18:22:05	Other remarks:
Image Camera Type	ThermaCAM E300	
Emissivity	0.95	
Object Distance	2.0 m	
Reflected Apparent Temperature	-13.0 °C	
Atmospheric Temperature	20.0 °C	
Sp1 Температура	-16.3 °C

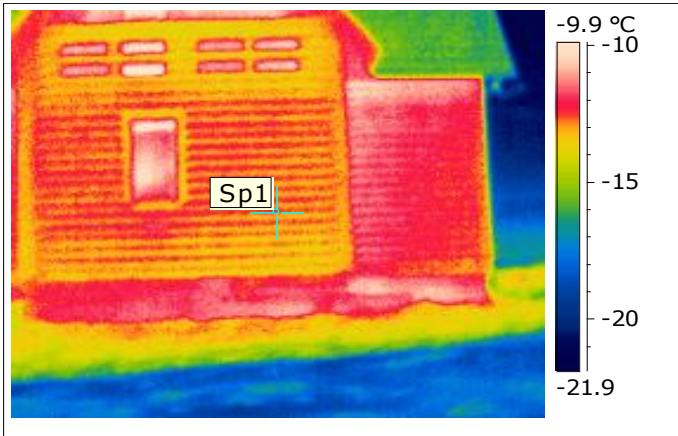
Date	14.12.2009	Location: (Where)
Image Time	18:00:33	Other remarks:
Image Camera Type	ThermaCAM E300	
Emissivity	0.95	
Object Distance	7.0 m	
Reflected Apparent Temperature	-13.0 °C	
Atmospheric Temperature	-20.0 °C	
Sp1 Температура	-13.2 °C
